SPORTSTER ISDN 128K TERMINAL ADAPTER RELEASE 5.4 NOTES

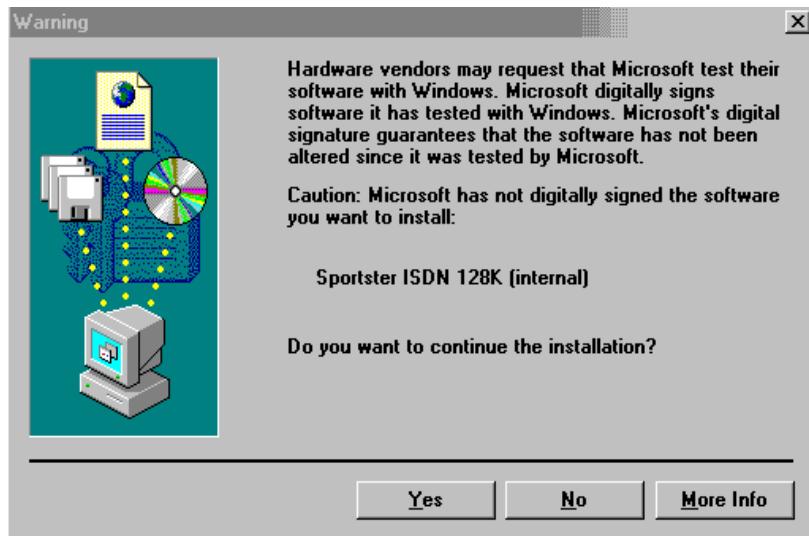
- 1 When you install the Sportster on a Window 98 operating system, you may see the following screen

The Sportster is compatible with Microsoft Windows 98, and you should press the **Yes** button to proceed with the installation.

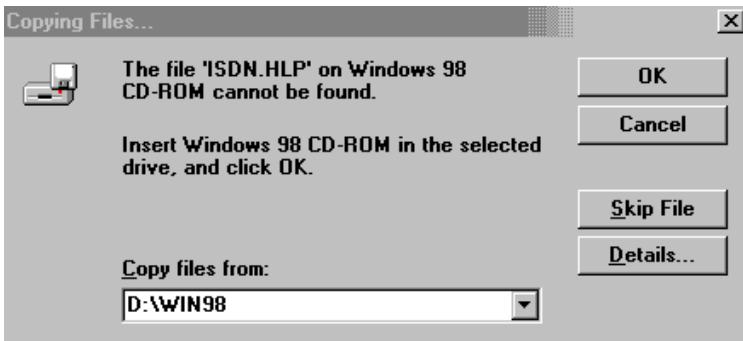
2 If you see the following screen during installation:

You should enter the Microsoft Windows 98 CD-ROM into your CD-ROM drive. Enter the path of your drive to the **Win98** directory and press the **OK** button.
